'Archaeology within the 18th century gardens of Horseheath Hall, Horseheath, Cambridgeshire'

Archaeology within the eighteenth century gardens of Horseheath Hall, Horseheath, Cambridgeshire.

Report No. A148

Commissioned by Miles Group

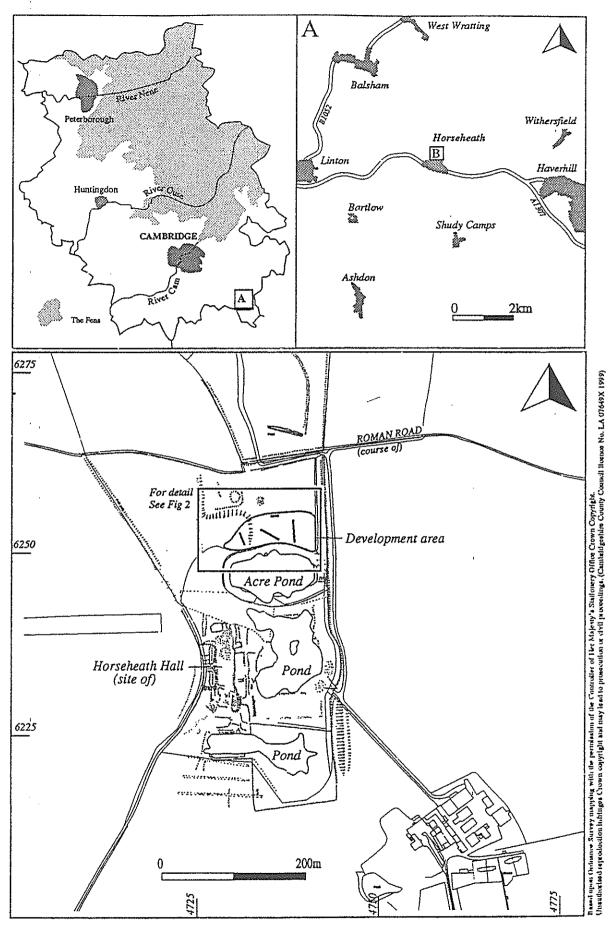
Figure 1 Location plan showing position of archaeological trenches and RCHM survey results

The investigation area lies at TL 623475, on the northern side of Acre Pond and immediately to the south of Hare Wood. Both are situated about 1 km to the east of the village of Horseheath and north of the A604 (Figure 1).

Trench plans are the result of a local co-ordinate survey undertaken with a Zeiss Recelta total station. The survey was rectified for presentation along with the Ordinance Survey digital map for the site (Figure 1).

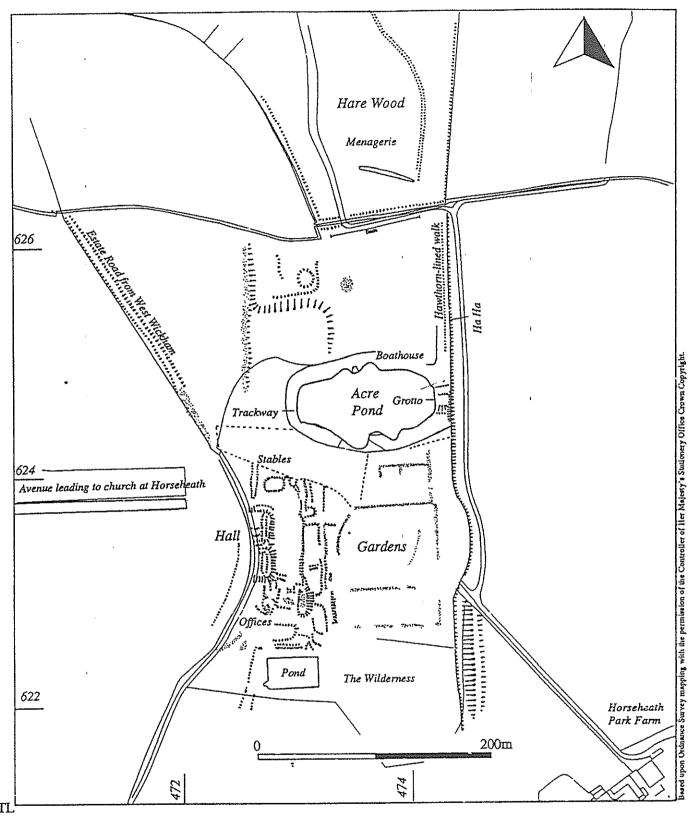
Figure 2 Plan showing results of 1990 RCHM survey of Horseheath Hall and environs (after RCHM)

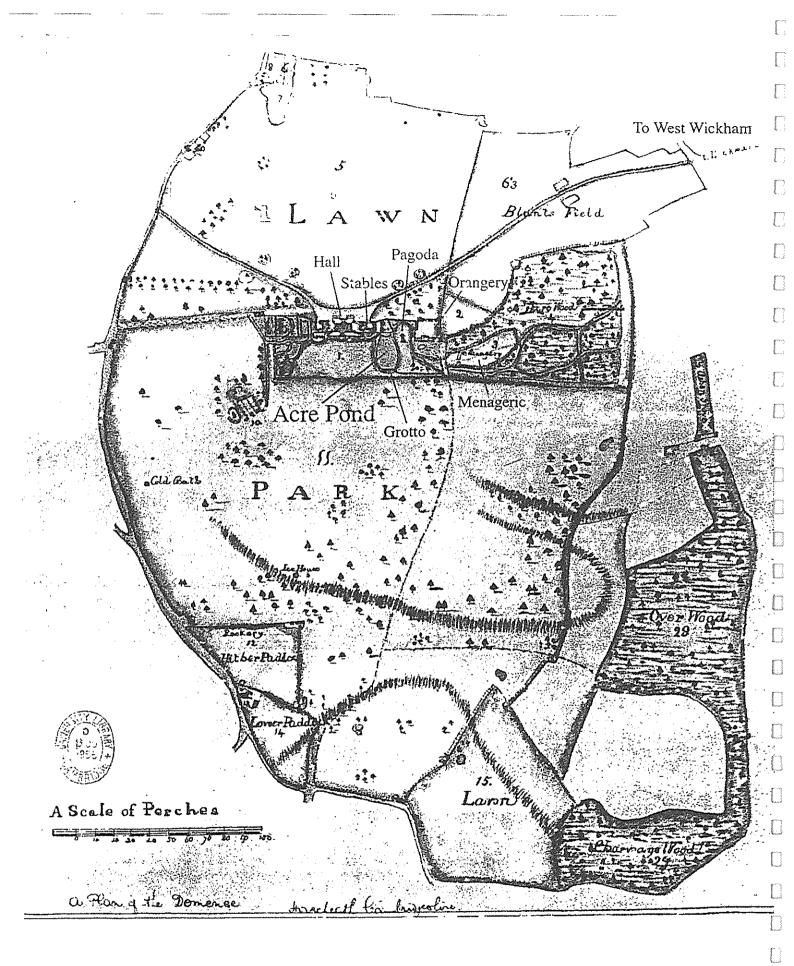
Figure 3 Plan of the Demense of Horseheath 1769 (C.U.L. Ms. Plans)

In 1775 financial problems resulted in the sale of the Hall and gardens and the park was disparked. At the end of the eighteenth century the Hall was demolished and sold for building materials. No above ground level remains of the Hall now survive, however, drawings and maps of the some of the features including the house and grotto do (Figure 4). The plan of the Demesne of Horseheath 1769/70 (CUL Ms Plans) shows the extent of the Hall and gardens at this time (Figure 3).

The estate was described in 1746/7 and surveyed again in 1769/70 (Figure 3) providing valuable source material.

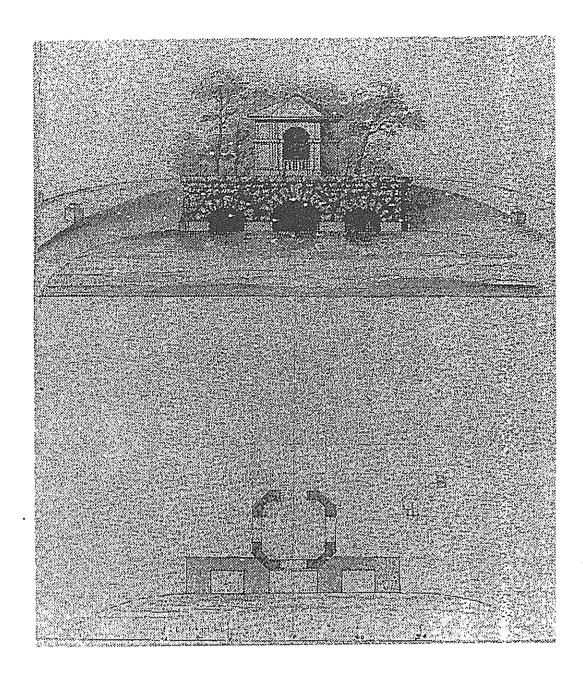
Figure 4 Design by William Kent for the Grotto pavilion at Horseheath Hall.

In 1990 a small mound was discovered on the eastern end of the pond which might be grotto designed by William Kent (Cocroft 1999; Dixon Hunt 1987) (Figure 4). Brick footings representing the site of the grotto survive along the lake edge at this point.

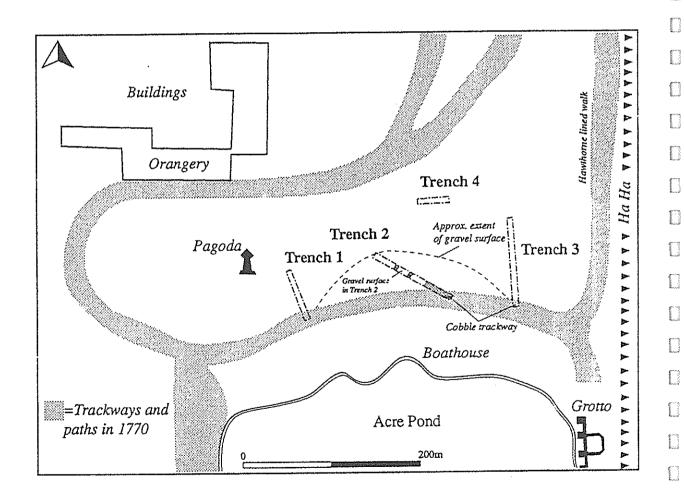
Figure 5 Detail of archaeological trenches, superimposed on a schematic plan based on the 1769/70 plan.

Although no remains of the monument were identified in Trench 1, on the northwestern side of Acre Pond lay a garden feature of unclear form. Dr Way suggests that this was a pagoda which would have been a typical feature of gardens of this period. The exact location and form of this feature remains unclear although an attempt to map its approximate location and how the proposed development will affect the immediate 1770 garden features is shown in Figure 5.
